## The contribution of ReLUIS to the usability assessment of school buildings following the 2016 central Italy earthquake

**Key words:** ReLUIS, central Italy earthquakes, usability and damage assessment, school buildings.

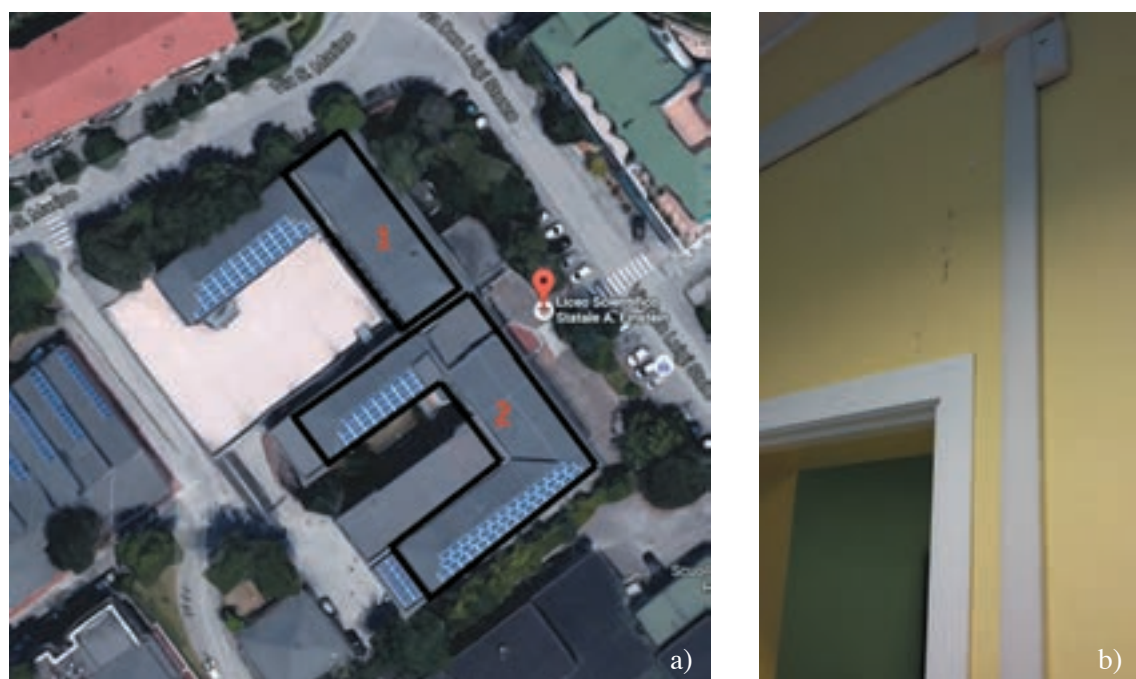
Fig. 7 - Einstein high school building: a) map view of the complex (No. 1 and No. 2 buildings are the oldest buildings); b) slight damage detected during the September 12, 2016 survey.

Visual inspection of the buildings showed no structural damage, while slight damage was found only in some internal partitions (Fig. 7b). Specifically, the detected damage to the partitions was null in the most recent buildings, and D1 (slight damage) with an extension of less than 1/3 in the older ones, according to AeDES form definitions (Baggio *et al.*, 2007a, 2007b).

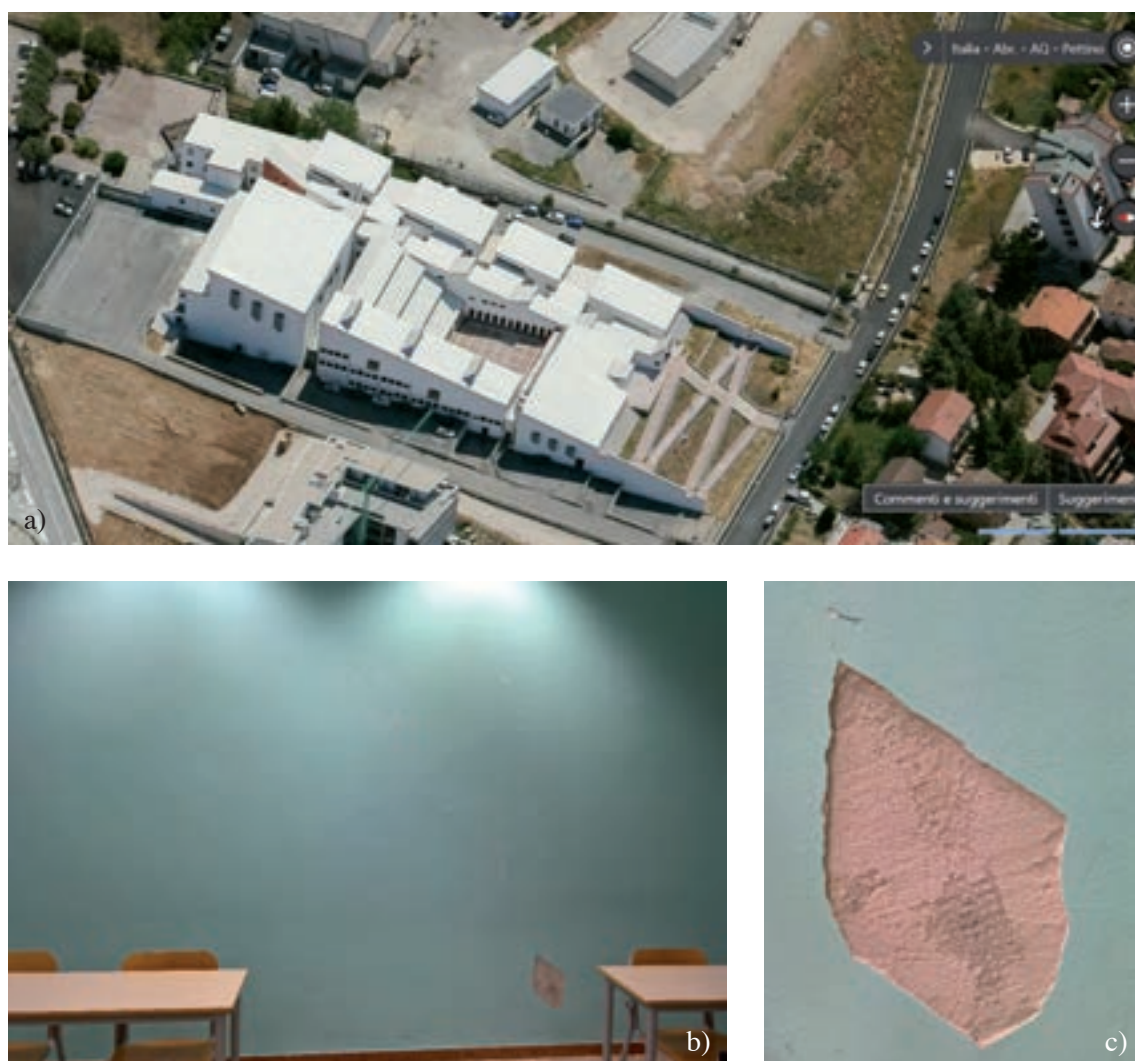
Fig. 8 - Cotugno high school building: a) plan view of the complex; b) and c) one of the damaged partitions after October 30, 2016 earthquake, plaster reinforcement mesh installed in 2009 is visible.

After the October 30, 2016 earthquake, during a field survey, slight damage was found on four partitions, illustrated in Fig. 8b. The plaster reinforcement grid installed on the partition in 2009 is visible in Fig. 8c. The school complex was declared usable, and re-opened once the minor damage was repaired.

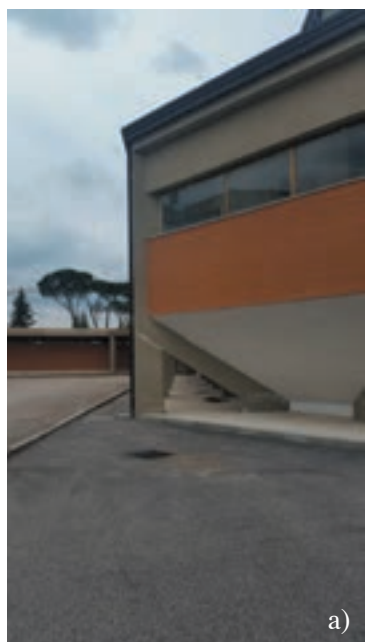
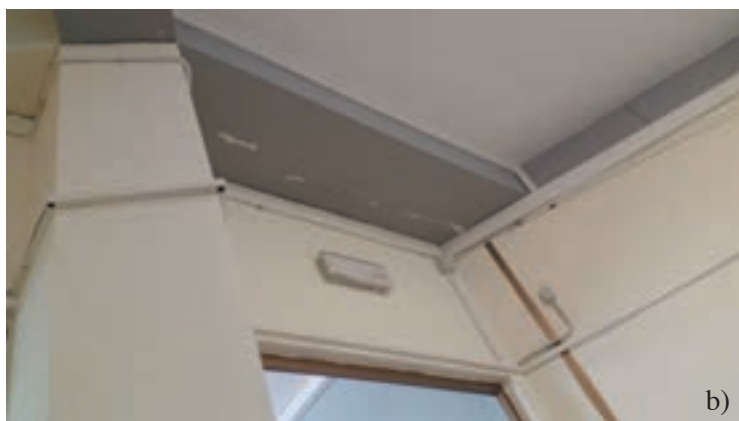
Fig. 9 - Ciancarelli high school building: a) RC columns of the gymnasium originally designed (end of 1970s) as short-span oblique cantilevers and modified by the addition of the vertical lower column during recent (2014-2015) seismic retrofitting; b) small cracks at the structural joint.

The building showed very limited damage after the August 24, 2016 earthquake. The seismic action recorded in Rieti, 44 km from the epicentre, was 0.06 g in terms of PGA. More specifically, during a survey on September 5, 2016, no significant damage was observed on the structural elements (frame structures, beam-column joints, roof, stairs), nor on the perimeter infill walls. The only exception was the separation between the original RC columns of the gymnasium and the new columns added below. A crack developed at the interface between old and new concrete, indicating a lack of or at least insufficient connection. Cracks were also observed on some internal partitions, especially near the structural joints, due to the movement between the portions of the structure (Fig. 9b). The school complex was declared usable.

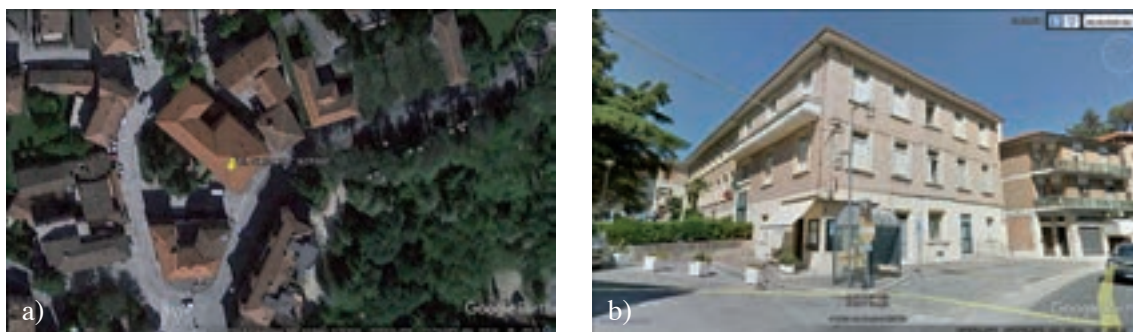
Fig. 10 - E. Ricciardi elementary school building: a) plan view of the school; b) external view of the building where the connectors installed after the 1997 central Italy earthquake are visible.

The building showed very limited damage after the  $M=5.9$  October 26, 2016 earthquake. More specifically, during the survey of October 28, 2016, no significant damage was observed on the structural elements, only slight diagonal cracks to some internal partitions and the spandrels of the central longitudinal walls. A crack developed at the interface between the masonry walls and the roof, indicating a lack or at least insufficient transverse connection. The closer inspection after the  $M=6.5$  October 30 event showed a general worsening of the damage level, both in terms of crack enlargements and detachment. Overall, however, the crack pattern was determined to be substantially the same as reported during the first survey. The school complex was declared usable.

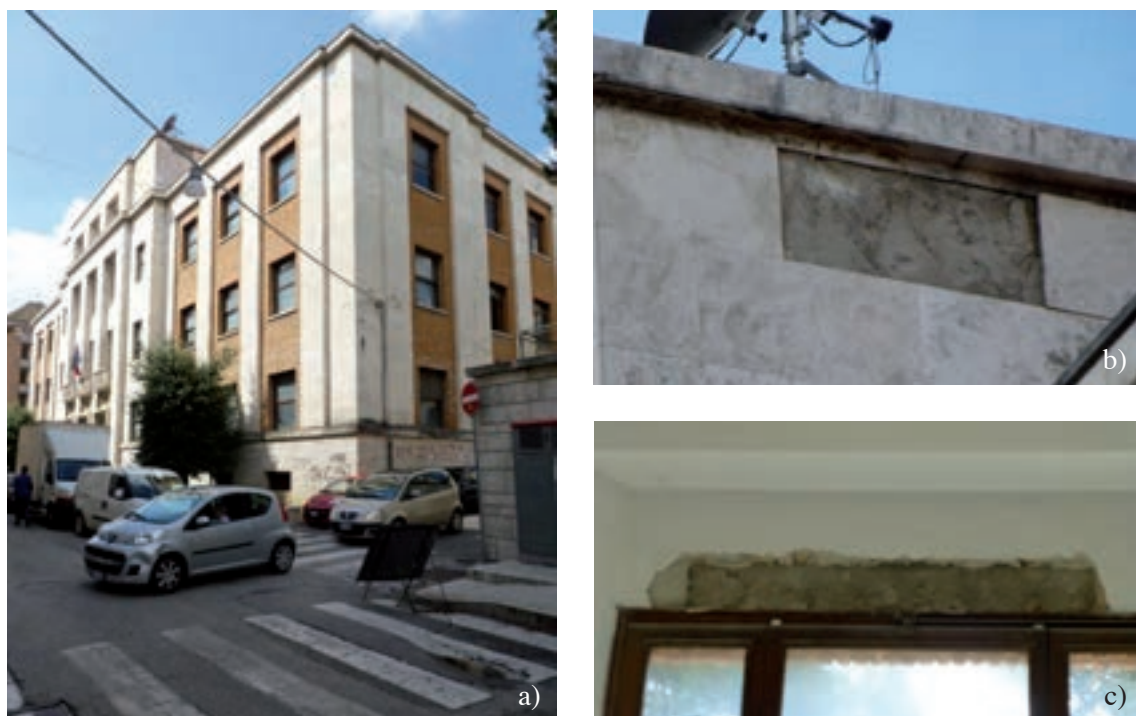
Fig. 11 - G. Milli high school building: a) external view of the complex; b) detachment of a travertine plate; c) detail of the collapsed plaster cover of the window lintel.

The school was inspected in the aftermath of the August 24 event and, despite a maximum PGA as low as 0.066 g, the main building was tagged as temporarily unusable and the lecture hall was tagged as unusable. Whereas the latter construction was affected by severe pre-existing damage to the roof, the main building was assessed temporarily unusable because of damage to non-structural elements. As a matter of fact, the main elevation shows a travertine stone cladding (Fig. 11a), and due to ground shaking, some plates detached from the back wall (Fig. 11b), precluding walking in the area below. The plates are connected to the load-bearing walls with mortar, but in a few cases, one or two metal ties per plate were observed. These ties were installed after the 2009 L'Aquila earthquake, which already highlighted the vulnerability of the façade.

More significant non-structural damage occurred within the building. In about ten classrooms a 40-60 mm-thick plaster cover of the window lintel cracked, and in some cases collapsed (Fig. 11c). The significant weight of such stucco finishing, usually loosely connected to clay brick fragments in order to obtain the desired thickness, posed a hazard to students. The observed

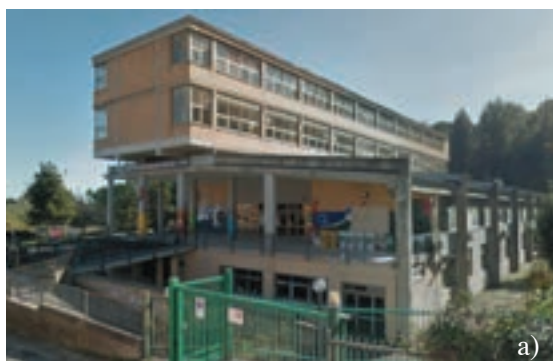
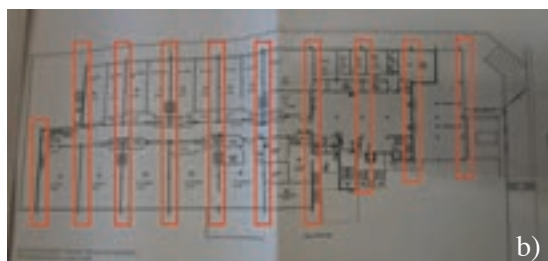
The structural system is composed of a series of RC transverse planar frames which are connected only by non-structural masonry infills along the longitudinal direction (Fig. 12b). The complete absence of an adequate structural lateral-resisting system along the longitudinal direction forced these stiff infills to act as bracing systems during the earthquake, but they were not strong enough. Thus, diffuse damage like typical diagonal and sub-horizontal cracks were observed on internal partitions at each storey during the survey. This was the result of the conceptual design of the original project, which was lacking in proper lateral-resisting systems in both directions.

Fig. 12 - O. Licini high school building: a) external view of the building; b) plan of an intermediate floor with the RC (transverse planar frames in red boxes).

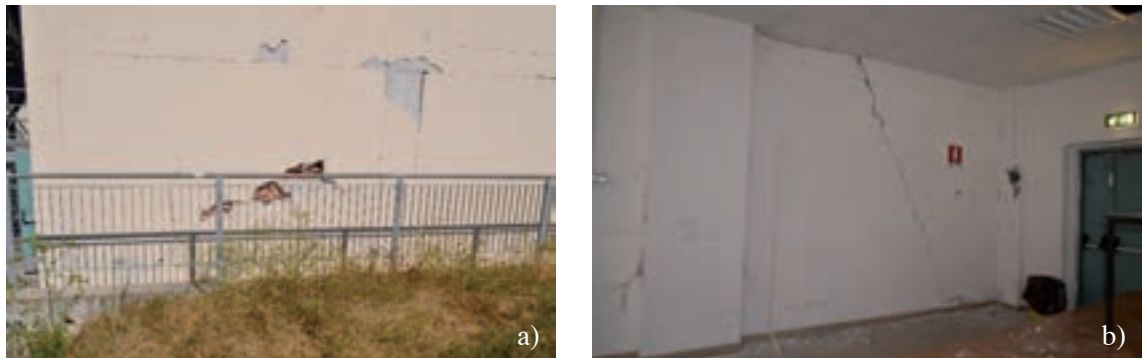
The second building is a RC frame building, built between 1997 and 2001. Inspection showed detachment from the frame of the external infills of the western façade both at the first and second floor (Fig. 13a), probably due to the poor connection between structural and non-structural elements. Diffuse damage like the typical diagonal and sub-horizontal cracks was also observed, with fall of some hollow bricks (Fig. 13b). The usability rating was B for both buildings.

Fig. 13 - R. Battaglia RC frame building: a) poor connection between structural and non-structural elements; b) diagonal and some sub-horizontal cracks in non-structural masonry infills.

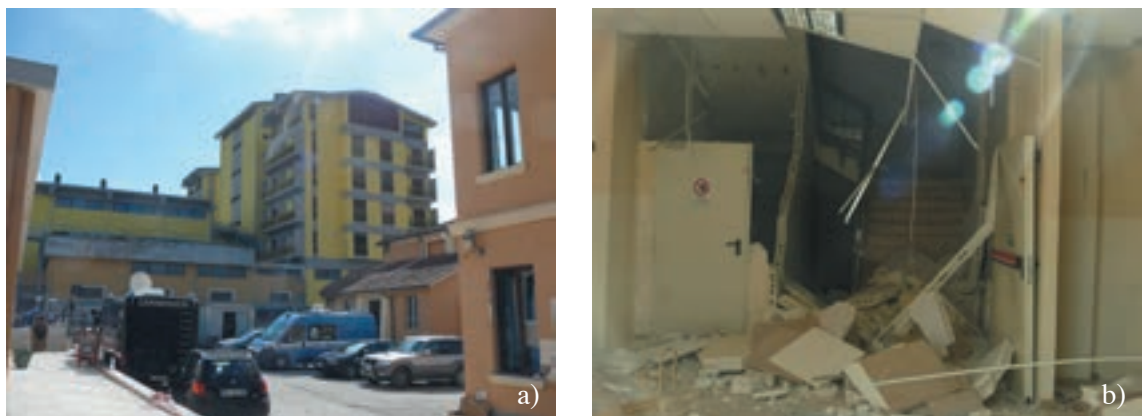
The **Hotel Management school** is one of the tallest buildings in Amatrice (Lazio), one of the most damaged municipalities in the August 24 earthquake. The school complex was built in the 1980s and hosted nearly 100 students. The structure, which has six floors, consists of RC frames that, on the outside, are infilled with clay masonry (Fig. 14a). Because the building is under criminal investigation, the inspection was carried out from the outside on October 3, 2016. Several aftershocks and earthquakes struck the building after this date, but the building has not collapsed. Inspection showed the collapse of several partition walls and ceilings, and cracking of the external walls. Furthermore, some external beams show tiny shear cracks. From the outside, it was possible to observe severe damage to the stairwell, with buckling of the RC ramp (Fig. 14b).

Fig. 14 - The Hotel Management school of Amatrice: a) external view of the building; b) collapse in the hall and damage of RC stairs.

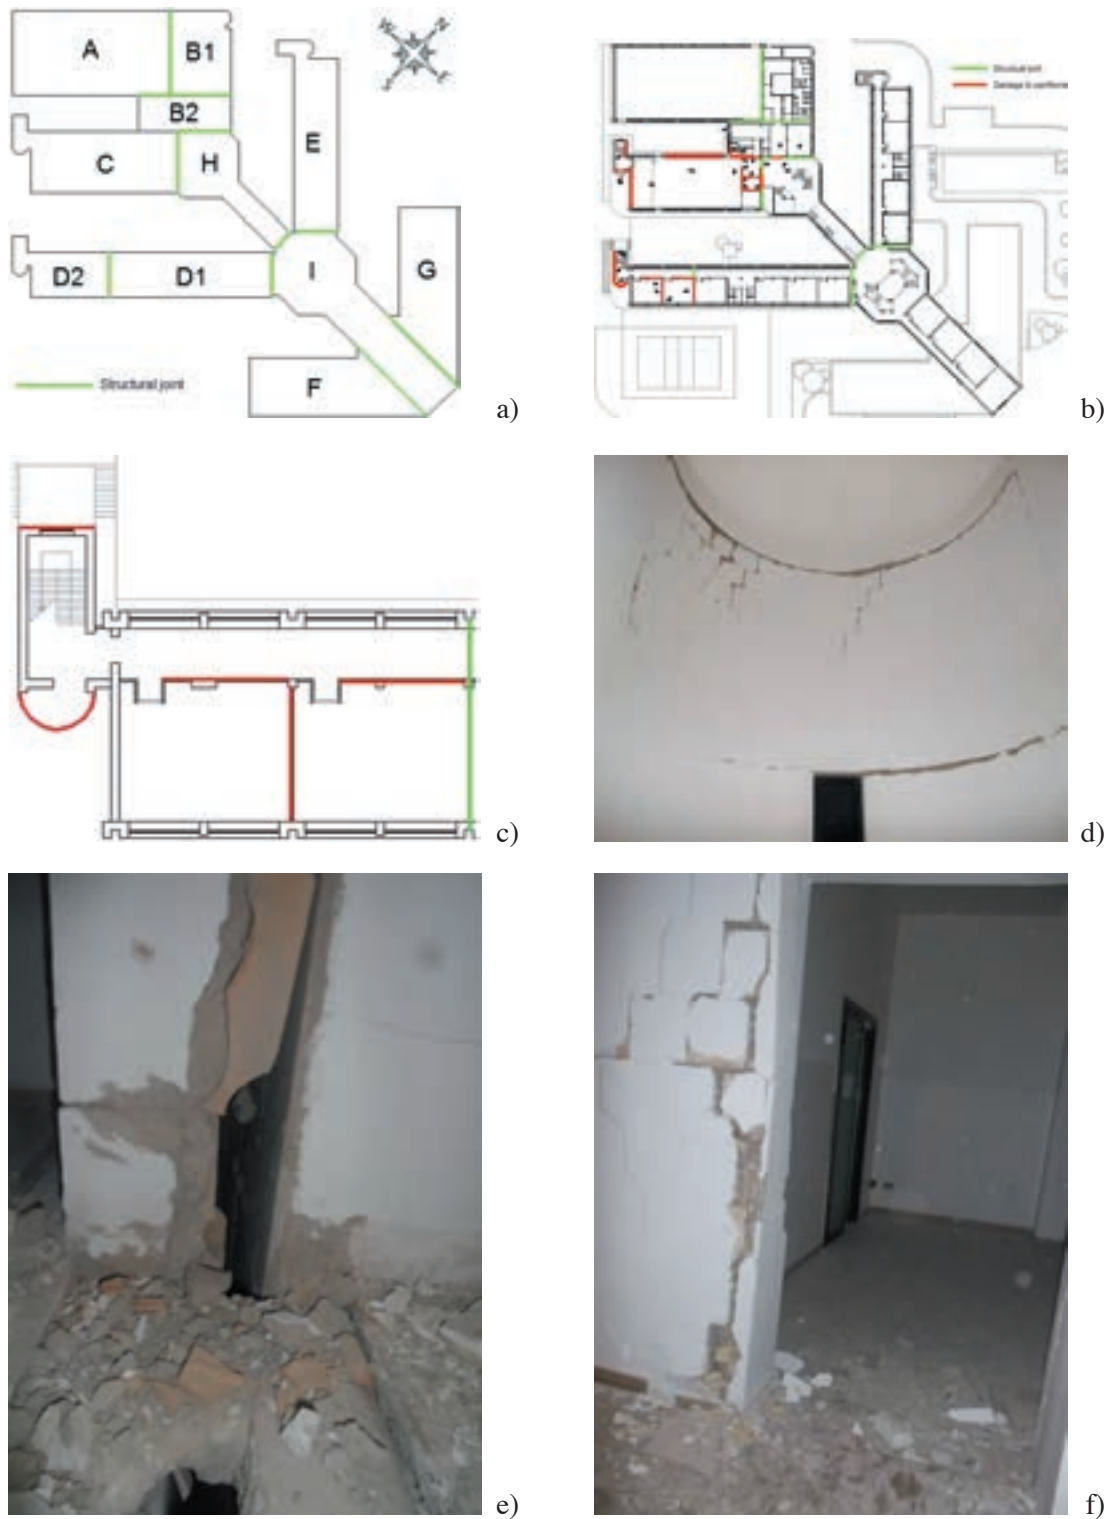
Fig. 15 - Pascal high school building: a) plan view of the complex and structural joints (green lines); b) location of the most significant damage (red line) in buildings D2, C, H, B2; c) and d) building D2 original project with eccentric damaged stairwell; e) damage to structural joint between buildings B2 and C; f) damage to non-structural masonry infills between buildings B2, C, and H.

The **Pascal high school** of Teramo (Abruzzo) is a RC structure with infill masonry walls, built in the 1990s. This school is regularly attended by 700 students and its area is about 9700 m<sup>2</sup>. The construction consists of eleven discrete structures divided by technical joints with a gap of about 7-10 cm (Fig. 15a). After the shock of August 24, the first survey was conducted on September 1, 2016 and damage was mainly found in buildings D2, C, H, and B2, as shown in Fig. 15b).

In building D2, damage was detected in the stairwell, which appeared out of plane (Figs. 15c and 15d). Out-of-plane behaviour of the infill walls was observed, with the risk of collapsing (Fig. 15d). For this reason, the area around the stairwell was declared off-limits.

Buildings B2, C, and H also show damage on infill walls due to insufficient structural joint (Figs. 15e and 15f), with a seismic pounding among buildings. After the shock of October 30, the dimension of the crack pattern significantly increased.

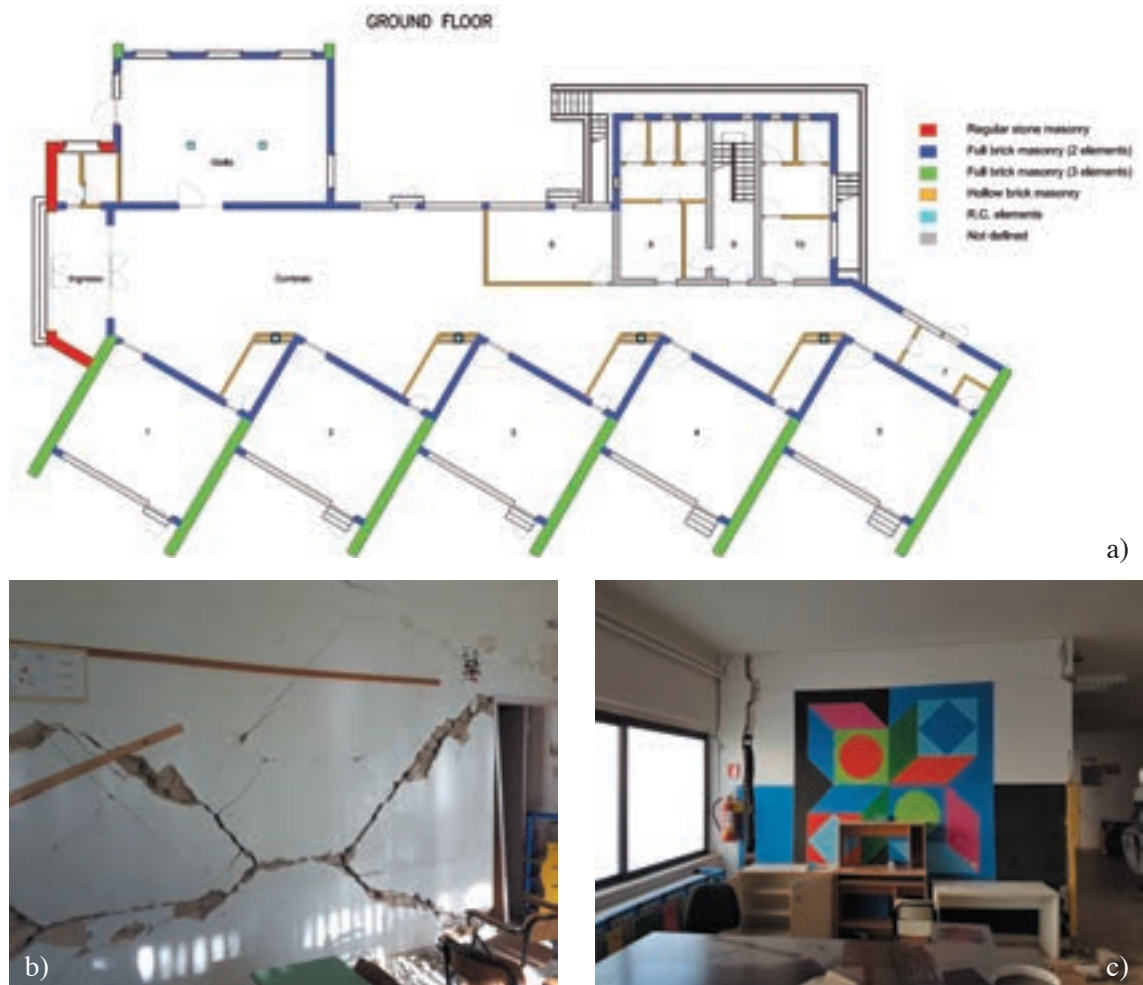
Fig. 16 - Mons. Paoletti elementary school building: a) ground floor plan with indication of structural elements; b) diagonal and c) sub-vertical cracks in non-structural masonry infills.

The building was tagged as unusable after the earthquake that struck the region on August 24. Figs. 16b and 16c show the cracking scenario on structural and non-structural elements, with indications of horizontal, verticals and diagonal cracks. Heavy damage to both internal and external masonry partitions and out-of-plane external walls, makes the building unusable and difficult to repair.

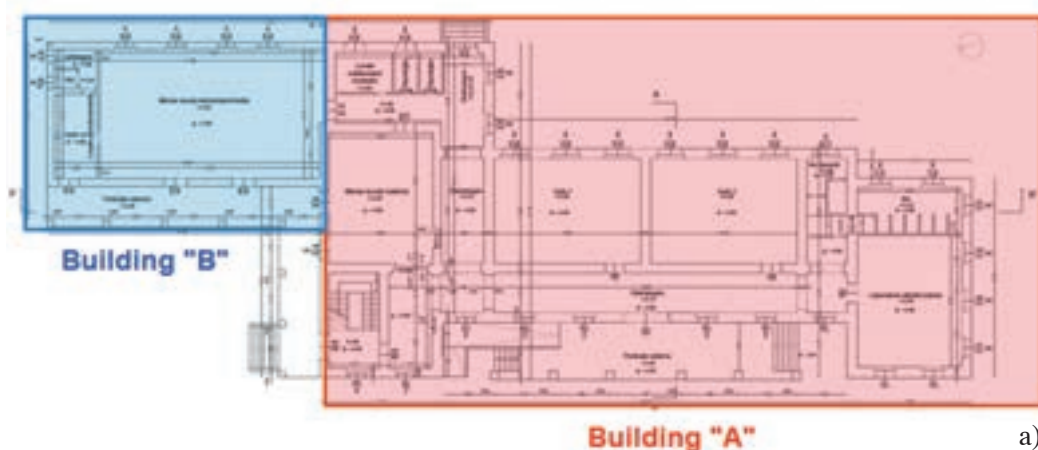
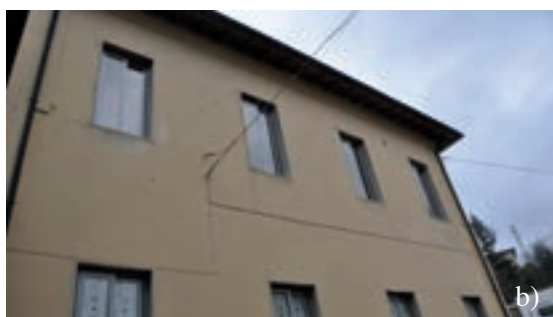
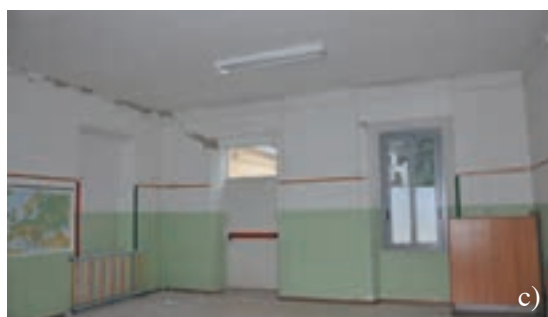
Fig. 17 - B. Tucci primary school building: a) plan view of the school complex; b) shear crack in vertical load-bearing elements; c) cracks between floor and masonry bearing walls.

The visual inspection after the  $M=6.0$  August 24 earthquake showed significant damage to more than two-thirds of the vertical load-bearing elements (Fig. 17b) and the non-structural partition walls. Damage to spandrels was also observed. The most evident damage was due to the interaction between the masonry piers and the RC slabs (Fig. 17c), both at the first and the second floor. The stairway structure showed minor damage after the first event, which became more significant after the two October events. Falling of plaster and internal objects was observed during the inspections.

The inspection of the structure after the two October events showed a general worsening of the damage level, both in terms of crack enlargements and falling plaster. Overall, the crack pattern was found to be substantially the same as reported during the first survey. No evidence of foundation settlement was observed after the three events.

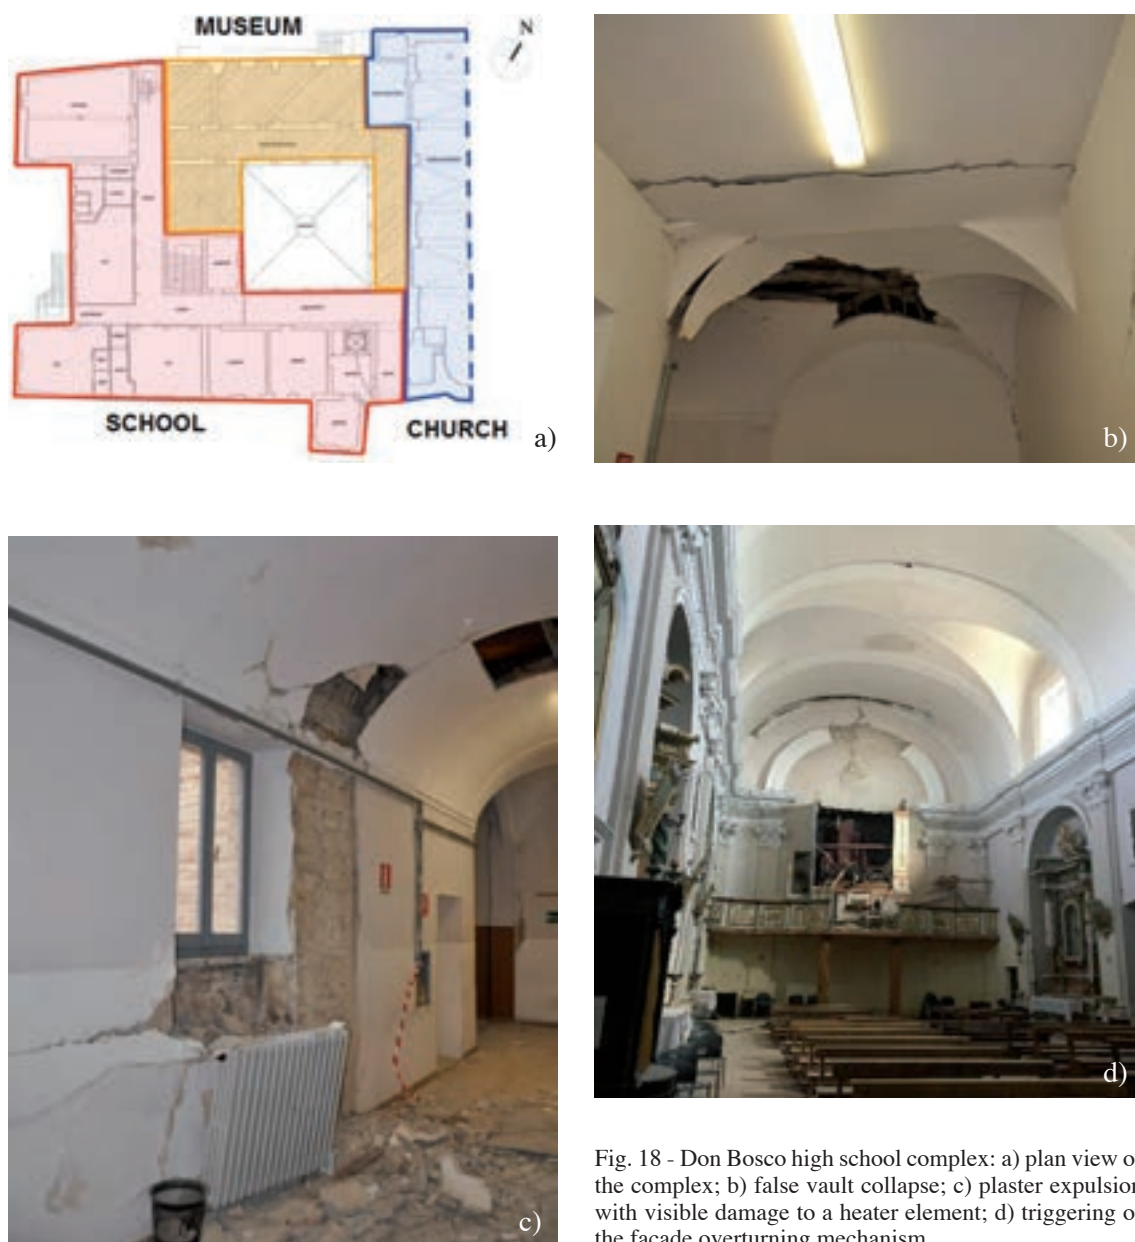
Despite the long epicentral distance (almost 50 km for the first event), the first visual inspection showed damage to some masonry piers and spandrels and significant damage to non-structural partition and infill walls. The inspections revealed severe damage and partial collapse of vaulted false ceilings (Fig. 18b), detachment of plaster (Fig. 18c), and falling of internal objects. Damage to the top of the bell tower (summit cone) created a dangerous situation on the outside of the building (the cone was removed a few days after the August 24 event from the top of the bell tower).

The church in the building complex showed evidence of structural damage (e.g., detachment of the façade) and non-structural damage (e.g., shattering of the organ) (Fig. 18d).

Fig. 18 - Don Bosco high school complex: a) plan view of the complex; b) false vault collapse; c) plaster expulsion with visible damage to a heater element; d) triggering of the façade overturning mechanism.

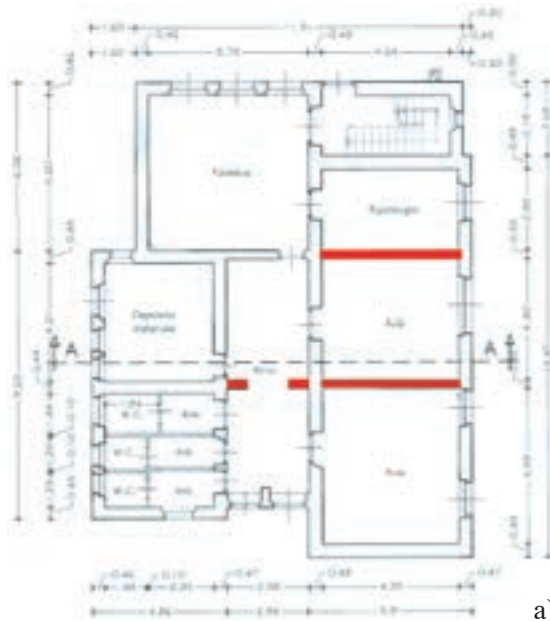
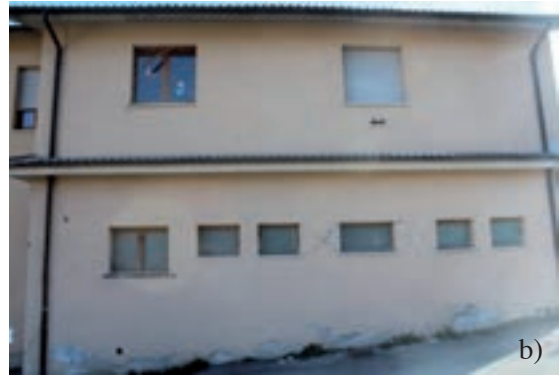
The site inspection showed evidence of structural damage (e.g., shear cracks on external walls) and non-structural damage (e.g., poor connection between the two types of masonry walls). Specifically, a sequence of small windows near one corner of the building strongly weakened the external wall, badly damaging a group of small squat walls during the earthquake (Fig. 19b).

Fig. 19 - G.M. Rizzi primary school building: a) ground floor plan; b) strip windows and damage.

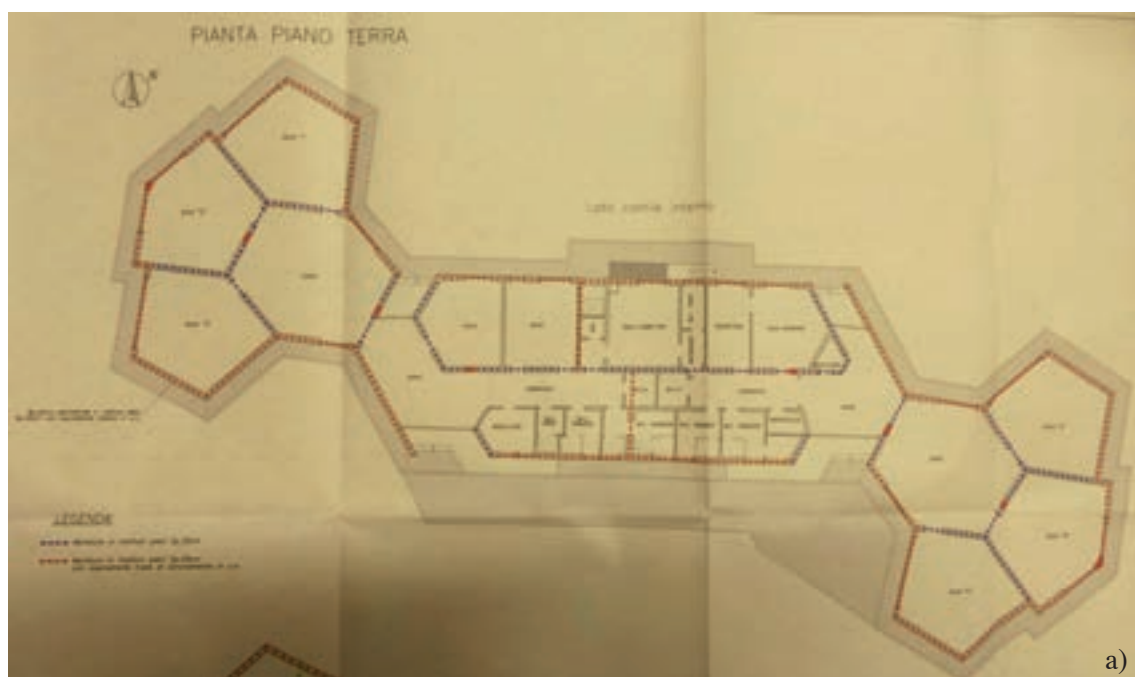
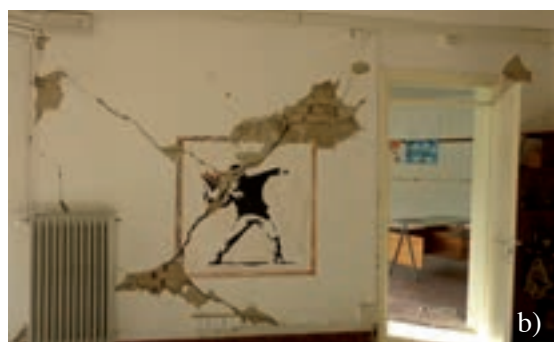
Nevertheless, the structure was still vulnerable due to planar irregularity (Fig. 20a), the narrowness of the masonry walls, especially in the lateral pavilions, and the low quality of the materials. The mortar was greatly deteriorated and could easily be pulverized by hand.

The school suffered minor damage after the August 24 earthquake, whereas it was severely damaged after the October seismic sequence. During on-site investigation carried out on December 17, strong damage was detected in the structural and non-structural elements (Fig. 20b). Severe torsional effects caused the shear failure of the inner and outer masonry walls, producing important X-shaped cracks ( $>1$  cm), the failure of the inner non-structural brick layer, and the dislocation of the bricks of the structural masonry walls. Due to the total wearing of the bed joints from repeated sliding, some adjacent brick layers were directly in contact after the crushing and expulsion of the mortar layer.

Fig. 20 - The elementary school of Pievebovigiana: a) ground floor plan; b) shear cracks in an inner wall of the east pavilion.
