The L'Aquila 2009 earthquake: an application of the European Macroseismic Scale to the damage survey in the epicentral area

R. AZZARO¹, M.S. BARBANO², S. D'AMICO¹, T. TUVÈ¹, L. SCARFI¹ and A. MOSTACCIO¹

¹ Istituto Nazionale di Geofisica e Vulcanologia, Sezione di Catania, Italy

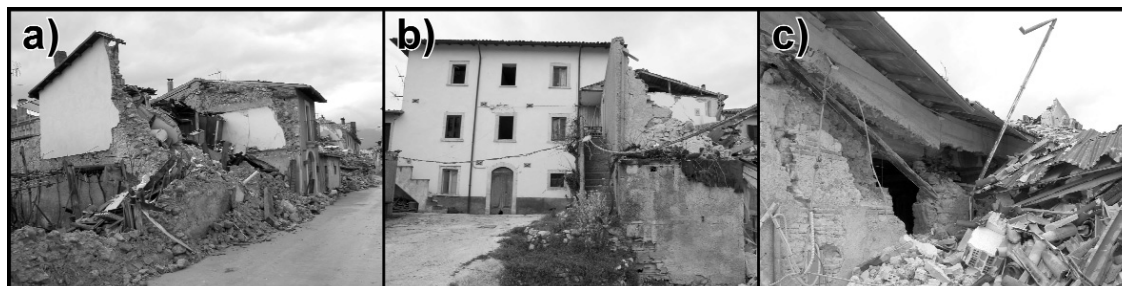
Fig. 2 - Examples of variation of the vulnerability class associated to masonry buildings: a) class B house with external intervention, but the collapse reveals a wall structure typical of vulnerability class A; b) class B edifice (in the background) where the reinforcing prevented significant damage, so the effective vulnerability class becomes C (photo by A. Tertulliani); c) class B house elevated and restored using different materials that create heterogeneity in the structure and overloading; the final behaviour is like a building of vulnerability class A.

- i) houses restored only in the external parts looking like buildings of vulnerability class B,

- indeed having the internal structure of the walls typical of structures of class A (Fig. 2a);
- ii) edifices with original vulnerability class B that, after a correct reinforcement intervention, behave better than class C buildings (Fig. 2b);
- iii) class B edifices restored with interventions overloading the entire structure, that resulted in an increase of vulnerability to the class A and hence to collapses (Fig. 2c).

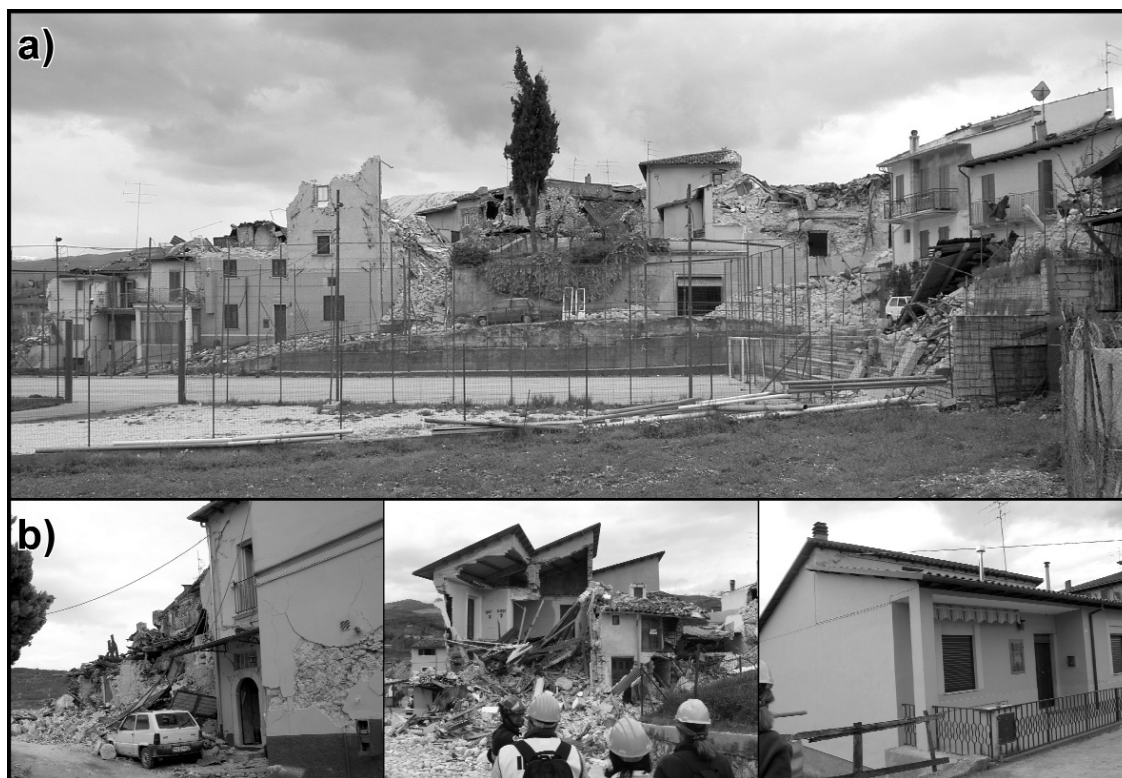
Fig. 3 - Onna: a) view of the village with several collapsed houses; b) inside the village, different damage grades depending on building typology.

In addition, the evaluation of the damage scenario was not simple because of the extension of some urban areas. As a result, damage appeared more concentrated in defined sectors and this could seem, at first sight, not fully representative of the overall urban territory (Figs. 3a and 3b).

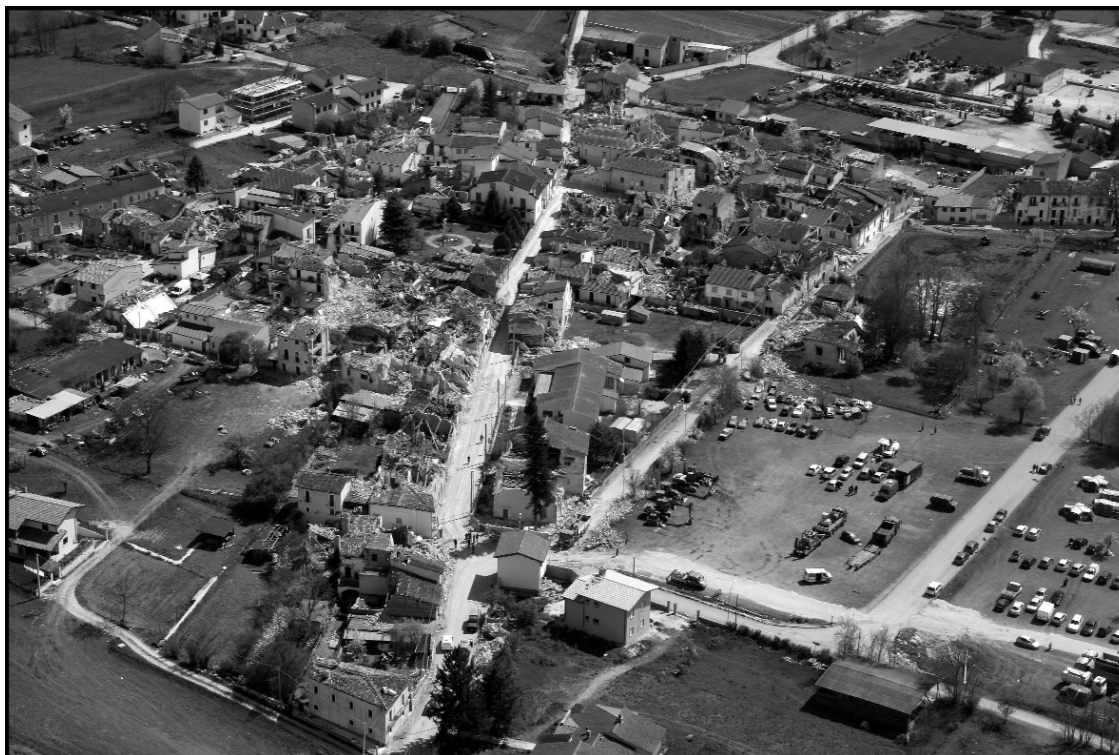
Fig. 4 - Onna (photo by A. Tertulliani): aerial view showing destruction but also standing edifices (grades 2 and 3 of damage).

The village of Onna was almost completely destroyed (Fig. 4). The case of this locality is exemplificative in the EMS perspective since, due to its small area, it is simpler to analyse. It

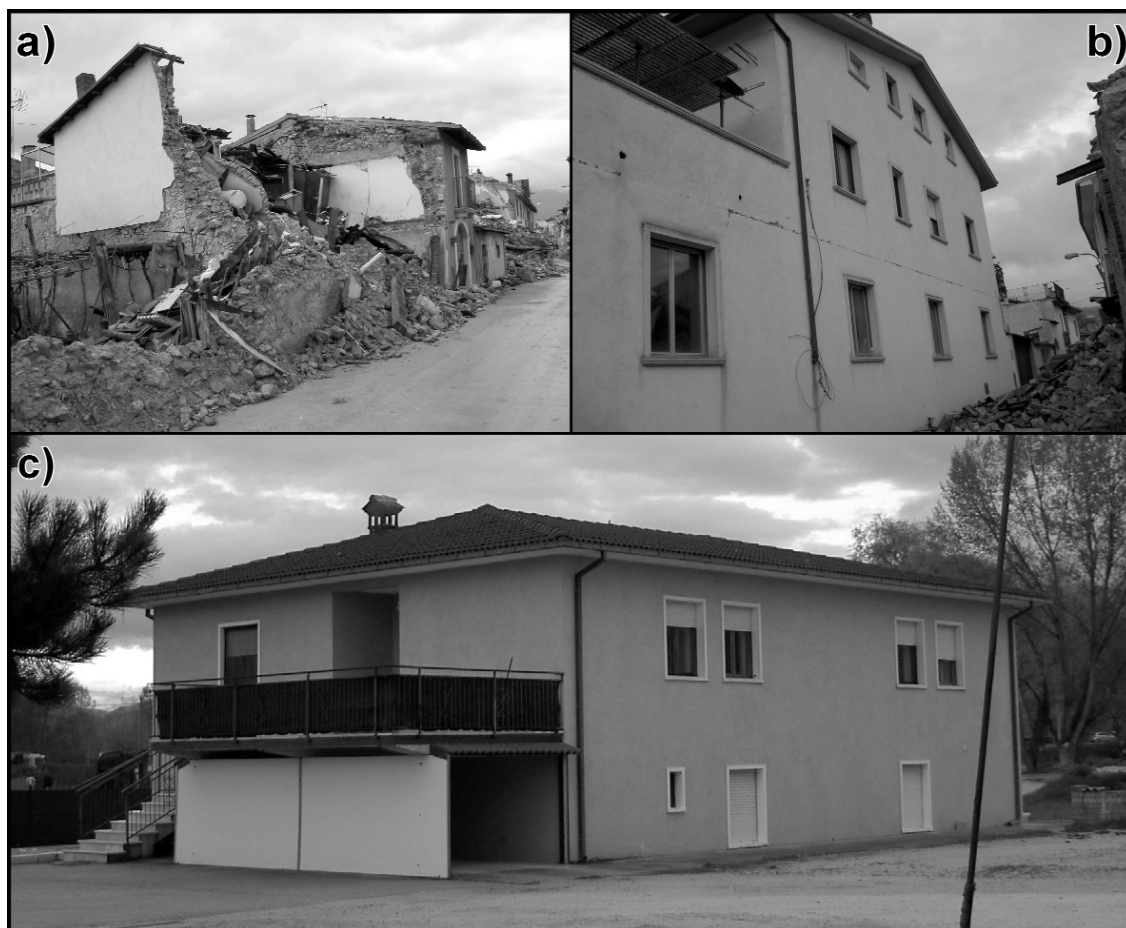
Fig. 5 - Onna, examples of damaged buildings with different vulnerability: a) class A, total collapse (grade 5); b) class C, slight damage (grade 2); c) class D, undamaged.

consists of 477 buildings (ISTAT, 2001), of which about 300 are considered to have vulnerability class A, 150 with class B, and 30 are C/D types (Fig. 5).

The collected data are shown in Fig. 1 and summarized in Table 1. We detected grade 3 damage (i.e., moderate level of structural damage) on many ordinary buildings with vulnerability classes B and C, i.e., masonry structures and RC frame edifices probably built before the introduction of the seismic code (no ERD was adopted). Grade 4 damage (very heavy damage, including partial collapse) was observed on many buildings with vulnerability class A and B, but also on a few C buildings. Finally, a few buildings with vulnerability class B and many of class A suffered damage of grade 5 (total collapse). The latest effects match the diagnostics expected for intensity IX in the EMS, but other damage, typical of such a degree, concerning grades 2 and 3 in buildings with vulnerability class D was not detected. In conclusion, the observed effects in Onna are consistent with the damage scenario reported at degree IX EMS, although in general class D edifices seem to have suffered less damage than scheduled by the scale.

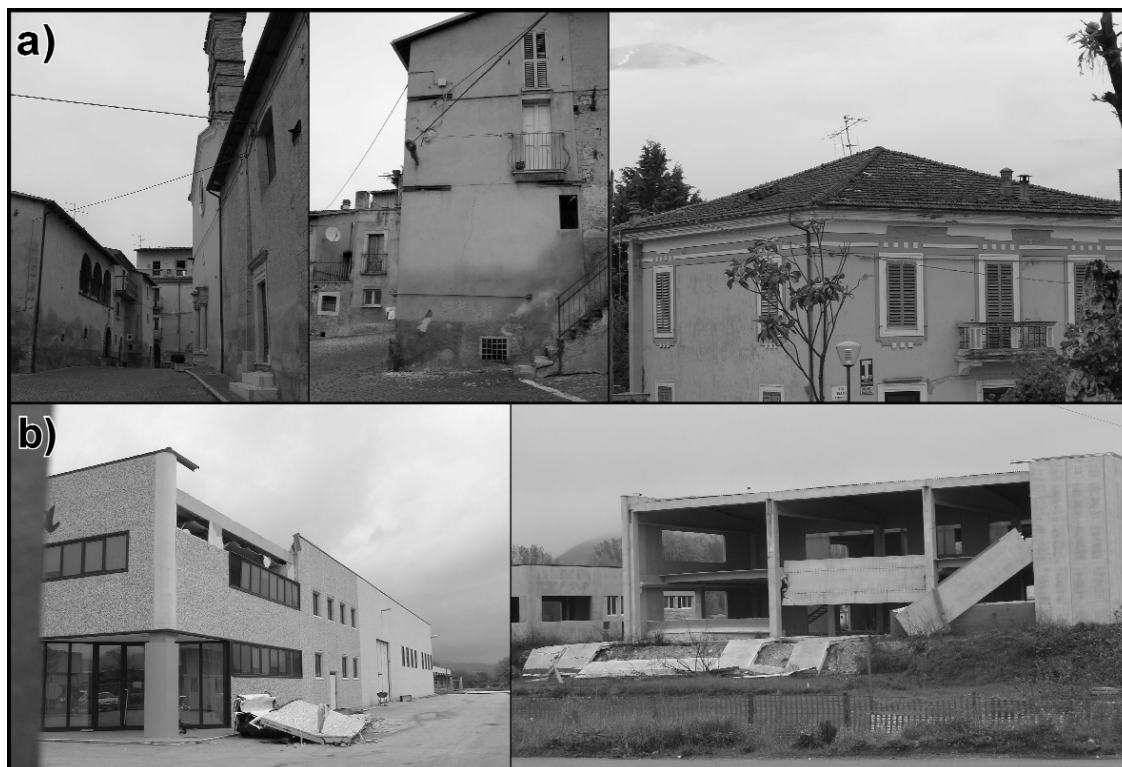
Fig. 6 - Monticchio, examples of damaged buildings with different vulnerability: a) historical centre, class B, slight damage (grades 1 and 2) (photo a, on the right by I. Cecic); b) industrial district, classes D-E, moderate damage (grade 3) (photo b, on the left by M. Godec).

The village of Monticchio is located just 2 km from Onna. The historical centre suffered slight damage, mainly of grade 2 (Fig. 6a) in a few edifices of classes B and C, and grade 3 in a few class A buildings. Since damage percentages are less than expected for intensity VII EMS, we preferred to consider the uncertainty and assess the degree VI-VII EMS. There is a very different situation for the industrial district, located a few hundreds of metres from the heart of the village on the road from L'Aquila to Monticchio. Here, some recent constructions such as prefabricated trading centres and factory buildings (classes D-E), showed heavy non-structural and moderate structural damage (grade 3, Fig. 6b), diagnostics scheduled in the degree IX. From the structural point of view, Menegotto (2009) suggests an apparent lack of connection between columns, beams and infill walls, that in practice means a higher vulnerability class (B-C). In our opinion, this is insufficient to account for such a marked damage difference in a very short distance. An important cause can be ascribed to a site amplification effect, because the industrial centre is located on the soft terrain of the alluvial plain while the old village of Monticchio stands on stiff

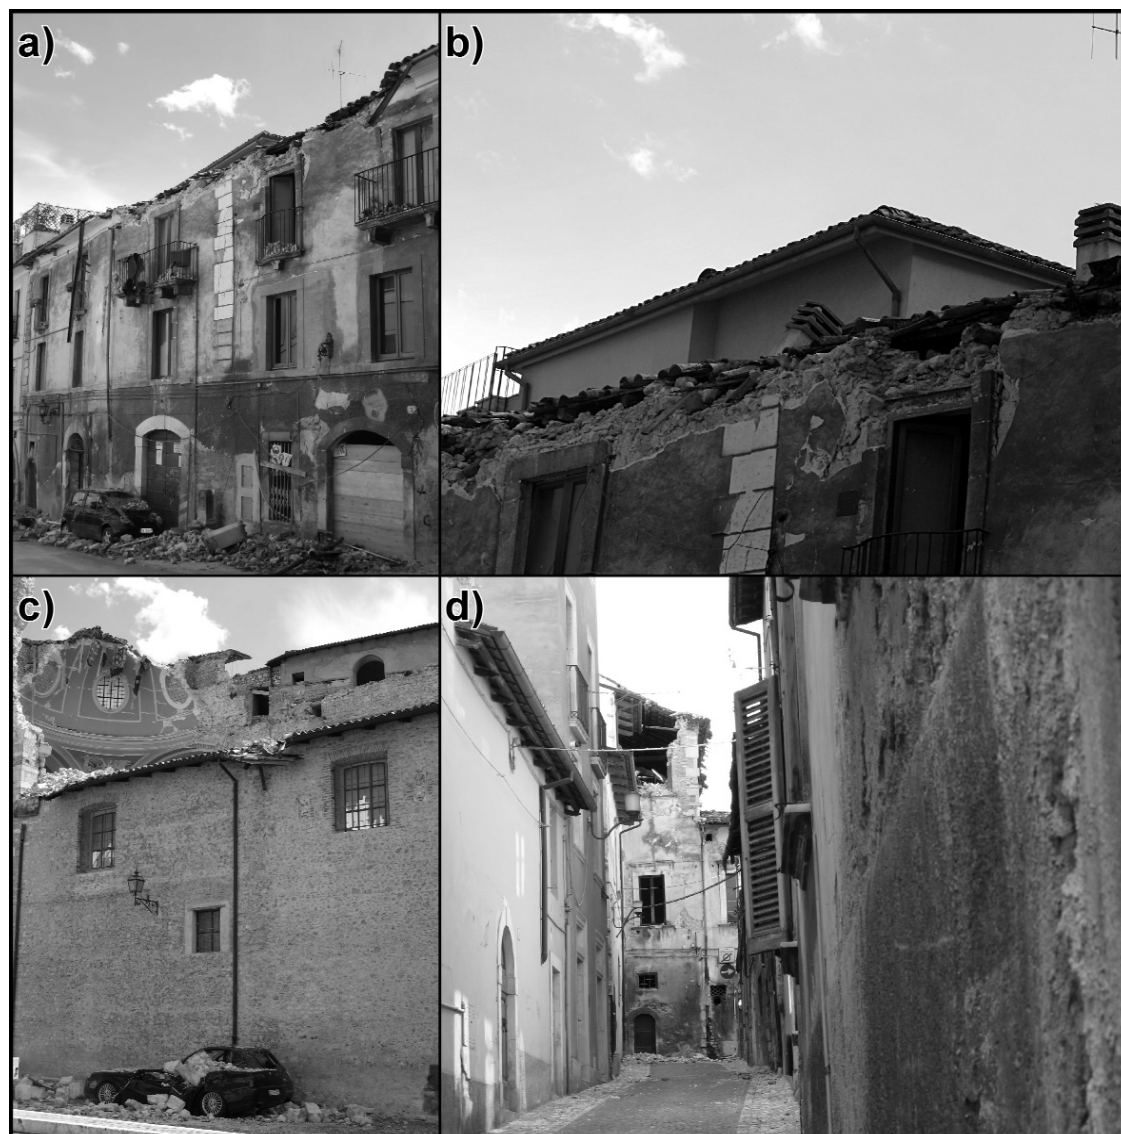
Fig. 7 - L'Aquila, historical centre, examples of damaged buildings with different vulnerability: a) ancient edifice with unsatisfactory maintenance; b) detail, the height of the building has recently been raised by one storey; c) church of St. Maria Paganica; d) restored and well-maintained houses coexist with abandoned ones, sharing lateral load-bearing walls.

The historical centre was heavily hit by the earthquake, not only for the high vulnerability of the poor building typologies but also for the presence of monumental buildings - by their very nature more vulnerable - as well as for the urban structure of the old town. Several churches, including the Cathedral, St. Augustine and the Collemaggio basilica, suffered partial or total

collapses of tympanums, vaults and perimetral walls, and in general other important damage. A large part of the historical centre consists of an agglomerate of edifices that are not separated from each other, sharing lateral load-bearing walls, where abandoned or even disrepaired houses (class A) stand next to well-maintained ones (classes B and C) (Figs. 7a and 7d). Most buildings have been raised by 1-2 stories and modified using different materials which create heterogeneity in the structures and overloading (Fig. 7b). All these situations have generally determined an increase of the vulnerability scheduled in the EMS for a given building typology, that in practise

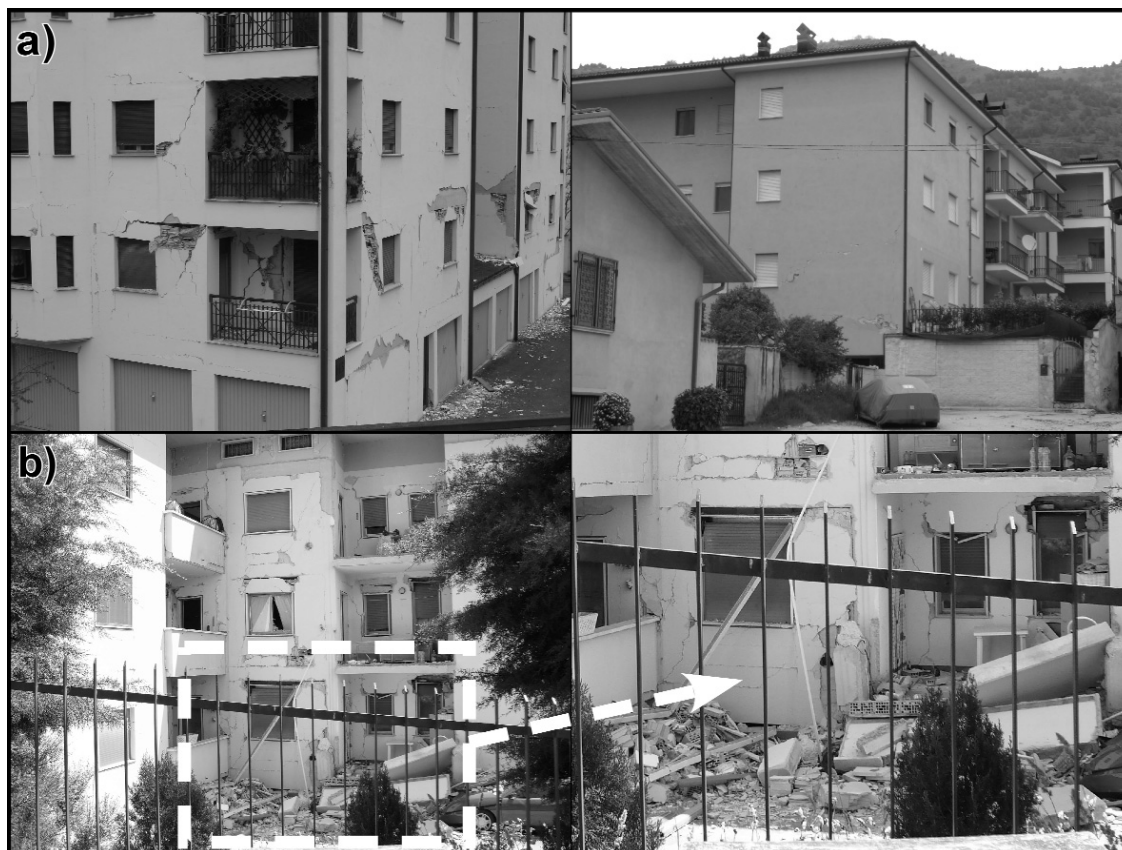
Fig. 9 - a) Casantessa, examples of damage of grade 3 in buildings with vulnerability classes C and D; b) Pettino, via Dante Alighieri, damage of grade 4-5 in buildings with 'theoretical' vulnerability class D (to be declassified to C).

By contrast, the nearby neighbourhood of Pettino suffered the heaviest damage. The most striking effect was observed in some very recent buildings of class D, i.e., the collapse of the ground floor (soft-storey) compressed from the load of the overlying storeys (Fig. 9b). The other damage is summarised in Table 4, where it is evident that most of the effects are distributed

between degrees VIII and IX EMS. The asterisk indicates the formal position of the aforementioned class D edifices in the diagnostics of degree X that is, if compared with the overall effects, clearly indicative of problems due to either construction defects (Cosenza *et al.*, 2009) or a different site response. For this reason, we have declassified them to class C buildings, thus estimating intensity VIII-IX.

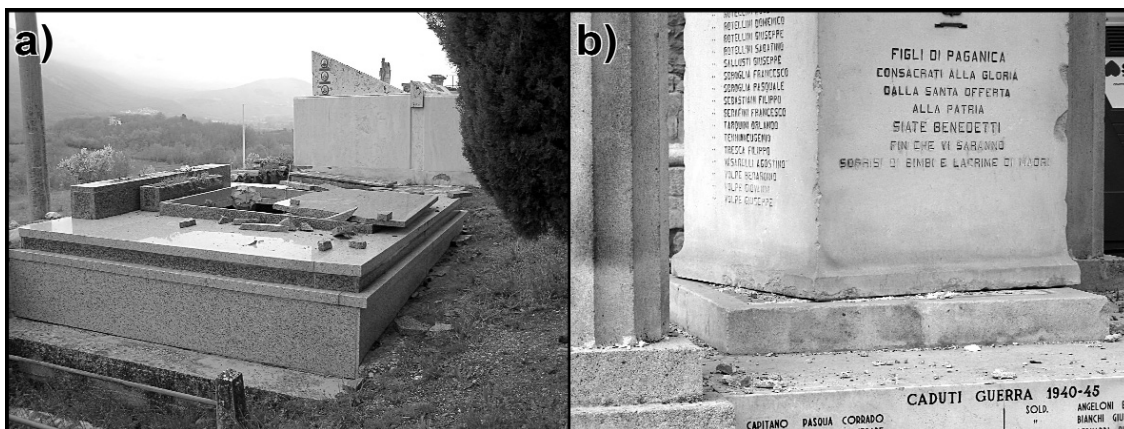
Fig. 11 - a) San Demetrio cemetery, overturned tombstone (photo by I. Cecic); b) Paganica, rotated war memorial.

In addition to Onna, L'Aquila-historical centre and Pettino, we estimated intensity VIII-IX EMS also at Sant'Elia and Castelnuovo, whereas about fifteen surrounding localities that suffered heavy damage, have been evaluated as degree VIII (see the Appendix). In brief, in all these localities we observed many buildings of vulnerability class A with damage of grade 4, some with damage of grade 5; many buildings of vulnerability class B with damage of grade 3, a few with damage of grade 4; a few buildings of vulnerability of class C with damage of grades 2 and 3. As an example, Table 6 reports the damage scenario surveyed at Fossa. In some cases, we also observed displaced tombstones or overturned monuments (Fig. 11), diagnostics explicitly
