# How the 1976 Friuli earthquake prompted research into the seismic behaviour of historical buildings and the formulating of effective and tailored seismic improvements

F. DOGLIONI<sup>1</sup>, S. GRIMAZ<sup>2</sup> and A. MORETTI<sup>3</sup>

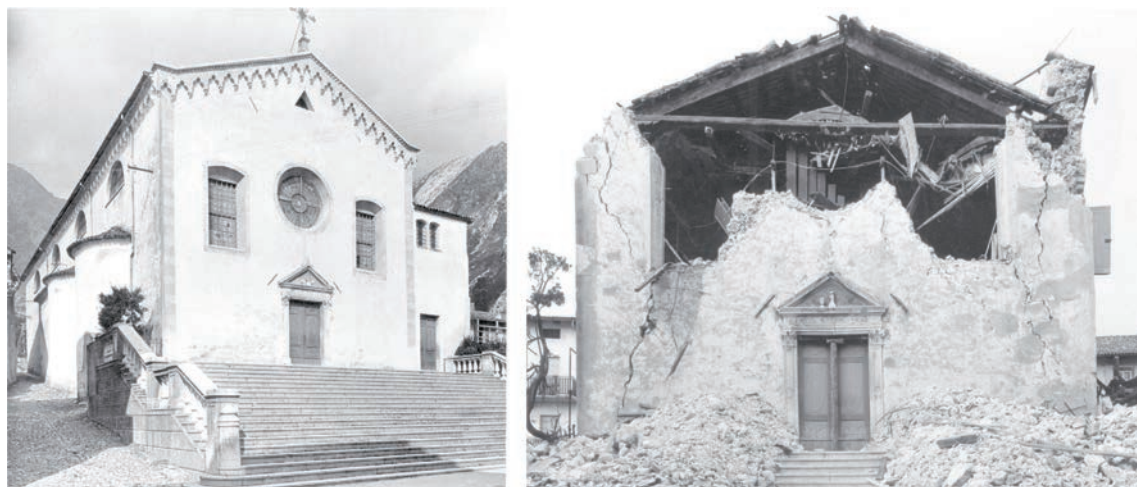
Fig. 1 - The church of Santa Maria degli Angeli in Gemona del Friuli (Udine province) before and after the earthquake of May 1976.

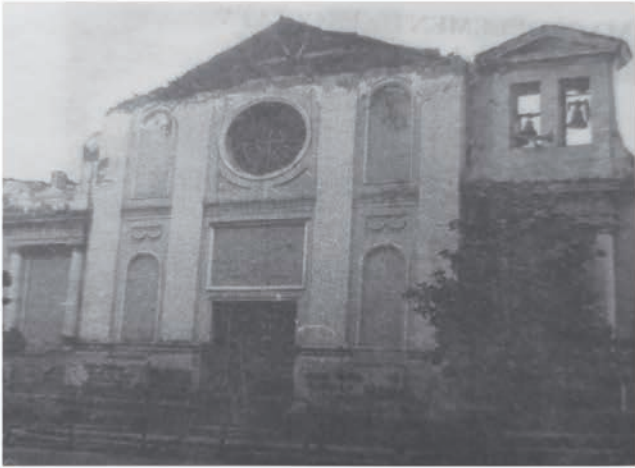
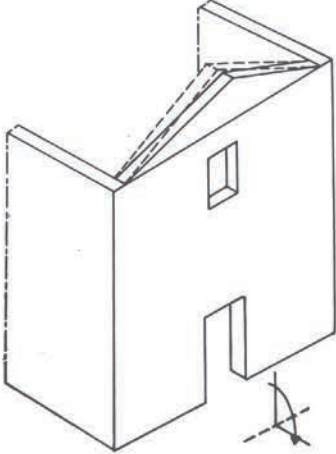
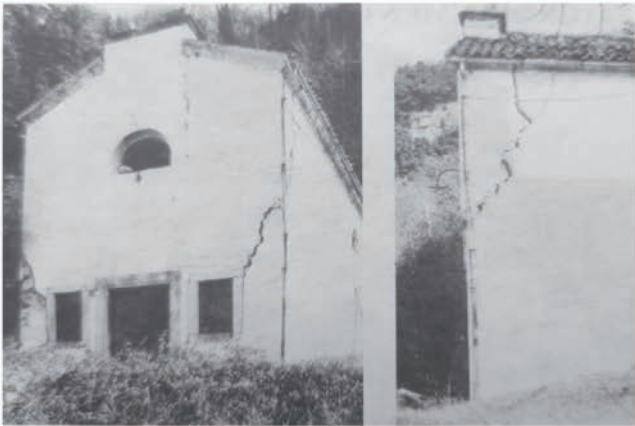
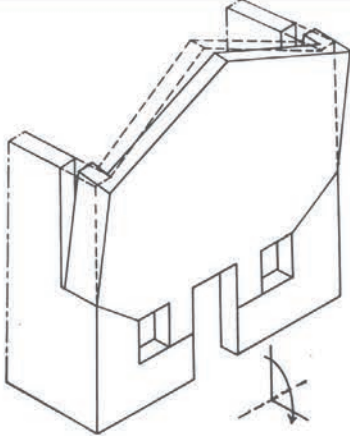
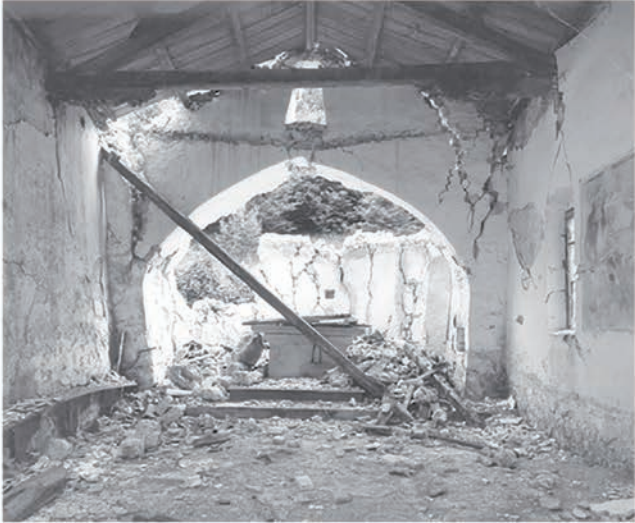
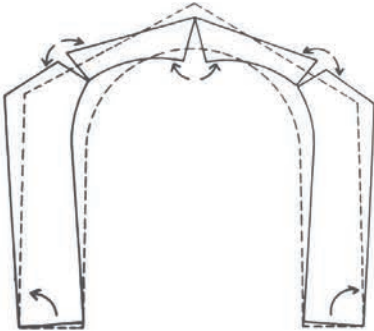
Damage (observed)	Mechanism

Fig. 3 - The damage on churches and the related mechanism scheme (modified from Dogliani *et al.*, 1994 and Dogliani, 2000).

In practice, the seismic behaviour of the churches was studied by separating the macro-elements of each church, and recognizing for each of them an almost autonomous seismic behaviour. For each macro-element, researchers carefully interpreted the damage to identify the already mobilized mechanisms or those that could be activated. This research on damage highlighted the repeatability of certain cracks and/or deformation phenomena in specific architectural parts, thus providing an initial series of expected damage on macro-elements identified in buildings belonging to similar architectural types. This evidenced the possibility of using these data for characterizing the vulnerability of buildings, by identifying the typical potential mechanisms correlated to specific architectural features of the macro-element.

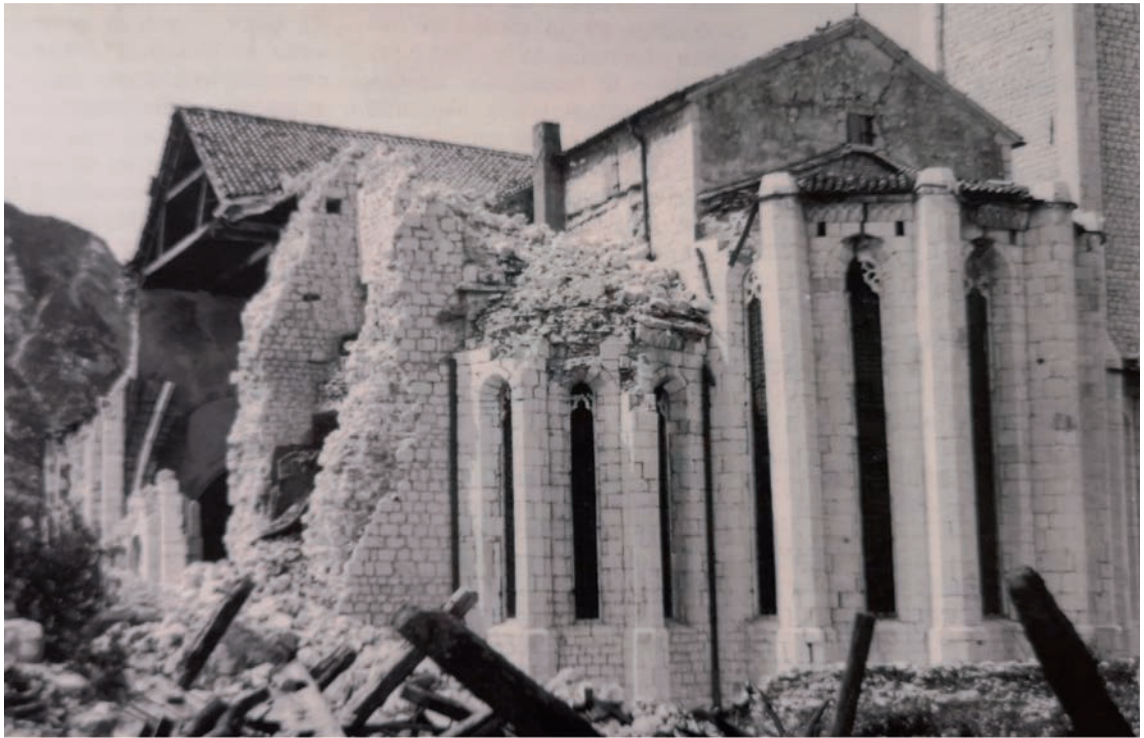
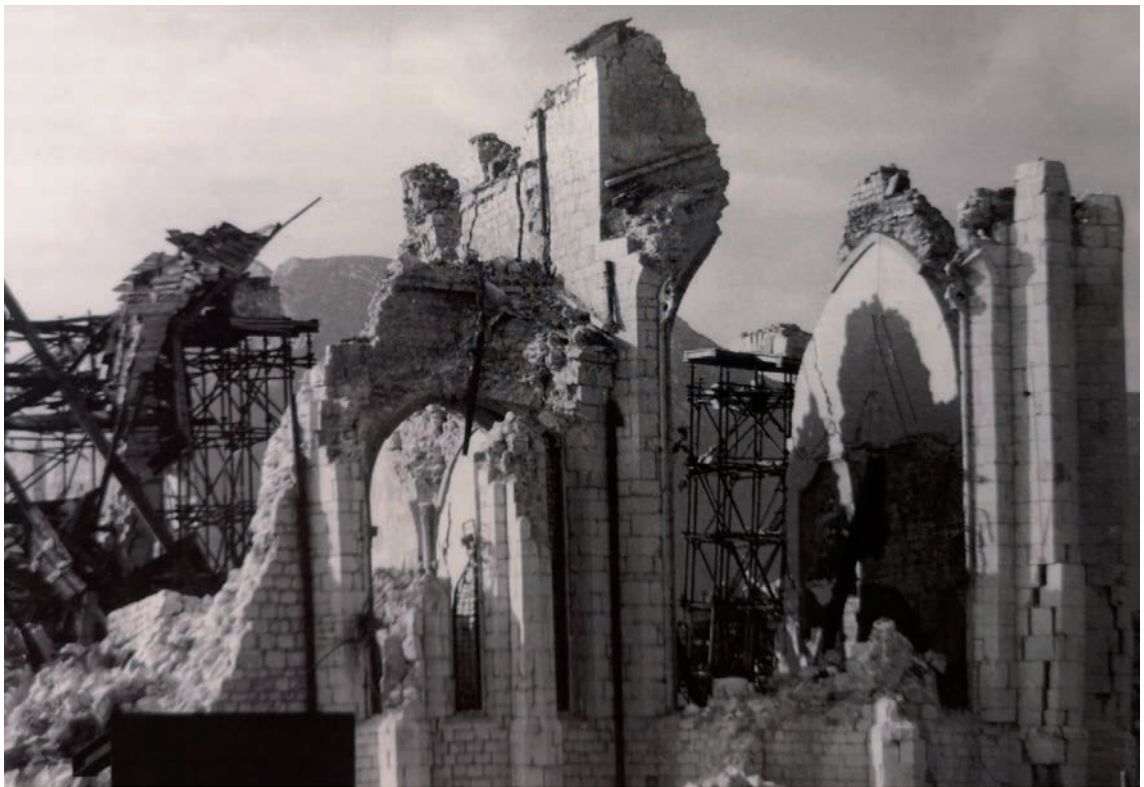
Fig. 5 - Progression of damage (modified from Doglioni *et al.*, 1994): the cathedral of Venzone a few days after the earthquake of 6 May 1976 (top) and after the events of September 1976 (bottom).

The massive and systematic acquisition of pictures from the very first moments after the 6 May earthquake allowed beginning to recognise the evolution and progression of damage. The damage progression is an effect of the aftershocks or of new earthquakes. Observations highlight that the damage progression is closely linked to the evolution of the mechanisms already activated by the first shock. This aspect is particularly evident when observing the consequences of the shocks of September 1976 in Friuli. Fig. 5 shows the progression of damage in the cathedral of Venzone, which was almost completely destroyed after the September events. The effects of damage progression were further recognised also in the subsequent Italian earthquakes in Irpinia (1980), Umbria-Marche (1997), Aquila (2009), Emilia (2012), and central Italy (2016) (Grimaz and Malisan, 2017).

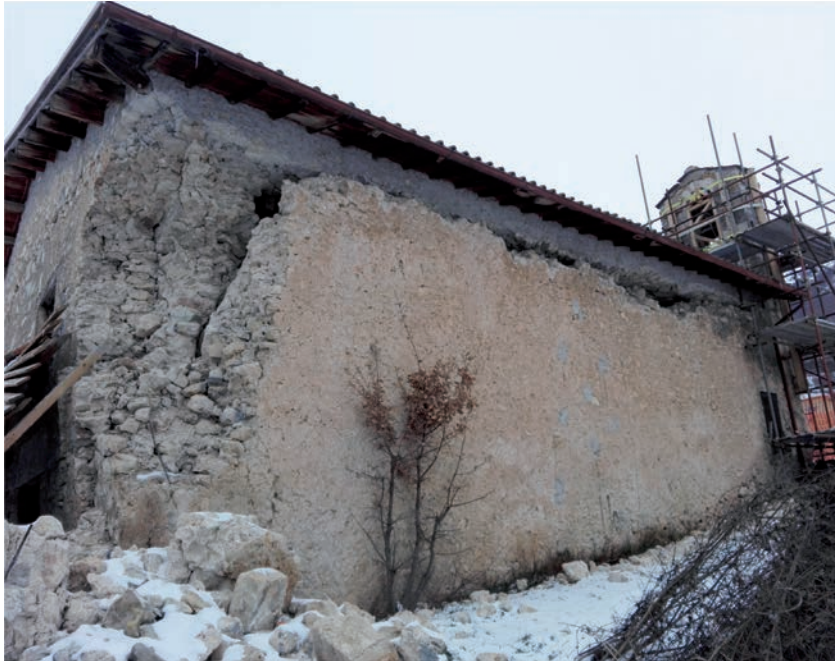
Fig. 7 - Church of Santa Giuliana, in San Pellegrino, Norcia (Perugia province, central Italy). The heavy beam supporting the roof is an intervention that introduced significant differences of stiffness or mass increase in the upper part of the building.

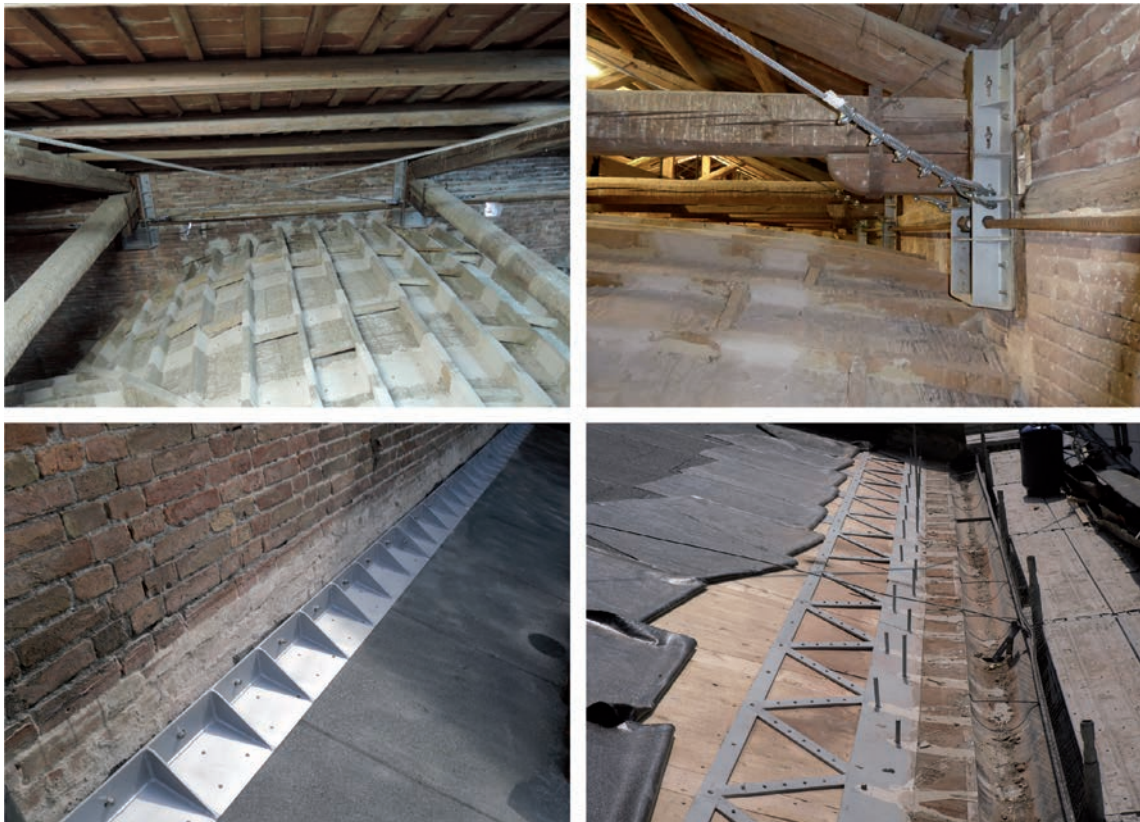
Fig. 8 - Example of problem-specific interventions based on Code of Practice criteria. Tailored solutions defined for the roof of the church of Beata Vergine Maria in Ostiglia (Mantua province) damaged by the 2012 earthquake in Emilia (northern Italy).
