Fig. 10

C.N.R.  
F. GODONE \*  
P. F. SORZANA \*  
Dir. E. VIOLA

LONGITUDINAL PROFILES

Plotted from aerial photographs

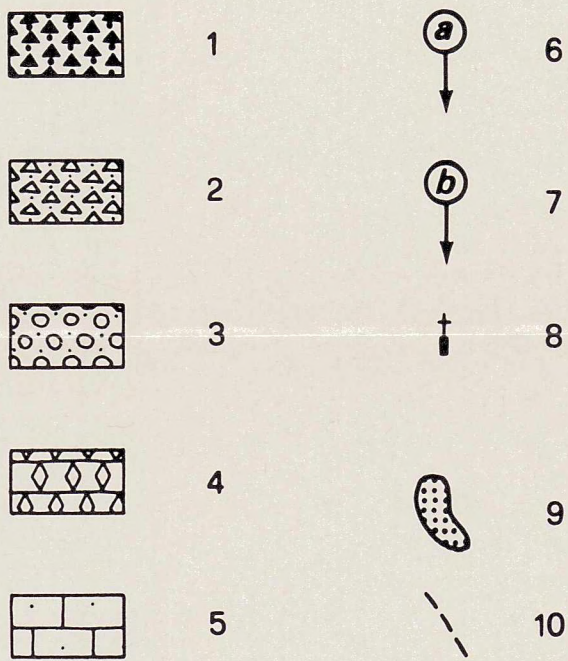
EXPLANATION

- 1) Accumulations of rock debris from landslides produced by seismic shaking.
- 2) Preexistent accumulations of rock debris.
- 3) Recent alluvial deposits.
- 4) Cemented breccias (Early Quaternary).
- 5) Dolomites and dolomitic limestones (Norian).
- 6) The most advanced position of single blocks fallen in consequence of the main shock of May 6, 1976.
- 7) The most advanced position of single blocks fallen in consequence of the main shock of September 15, 1976.
- 8) Church.
- 9) Rockfalls.
- 10) Approximate location of longitudinal profiles.

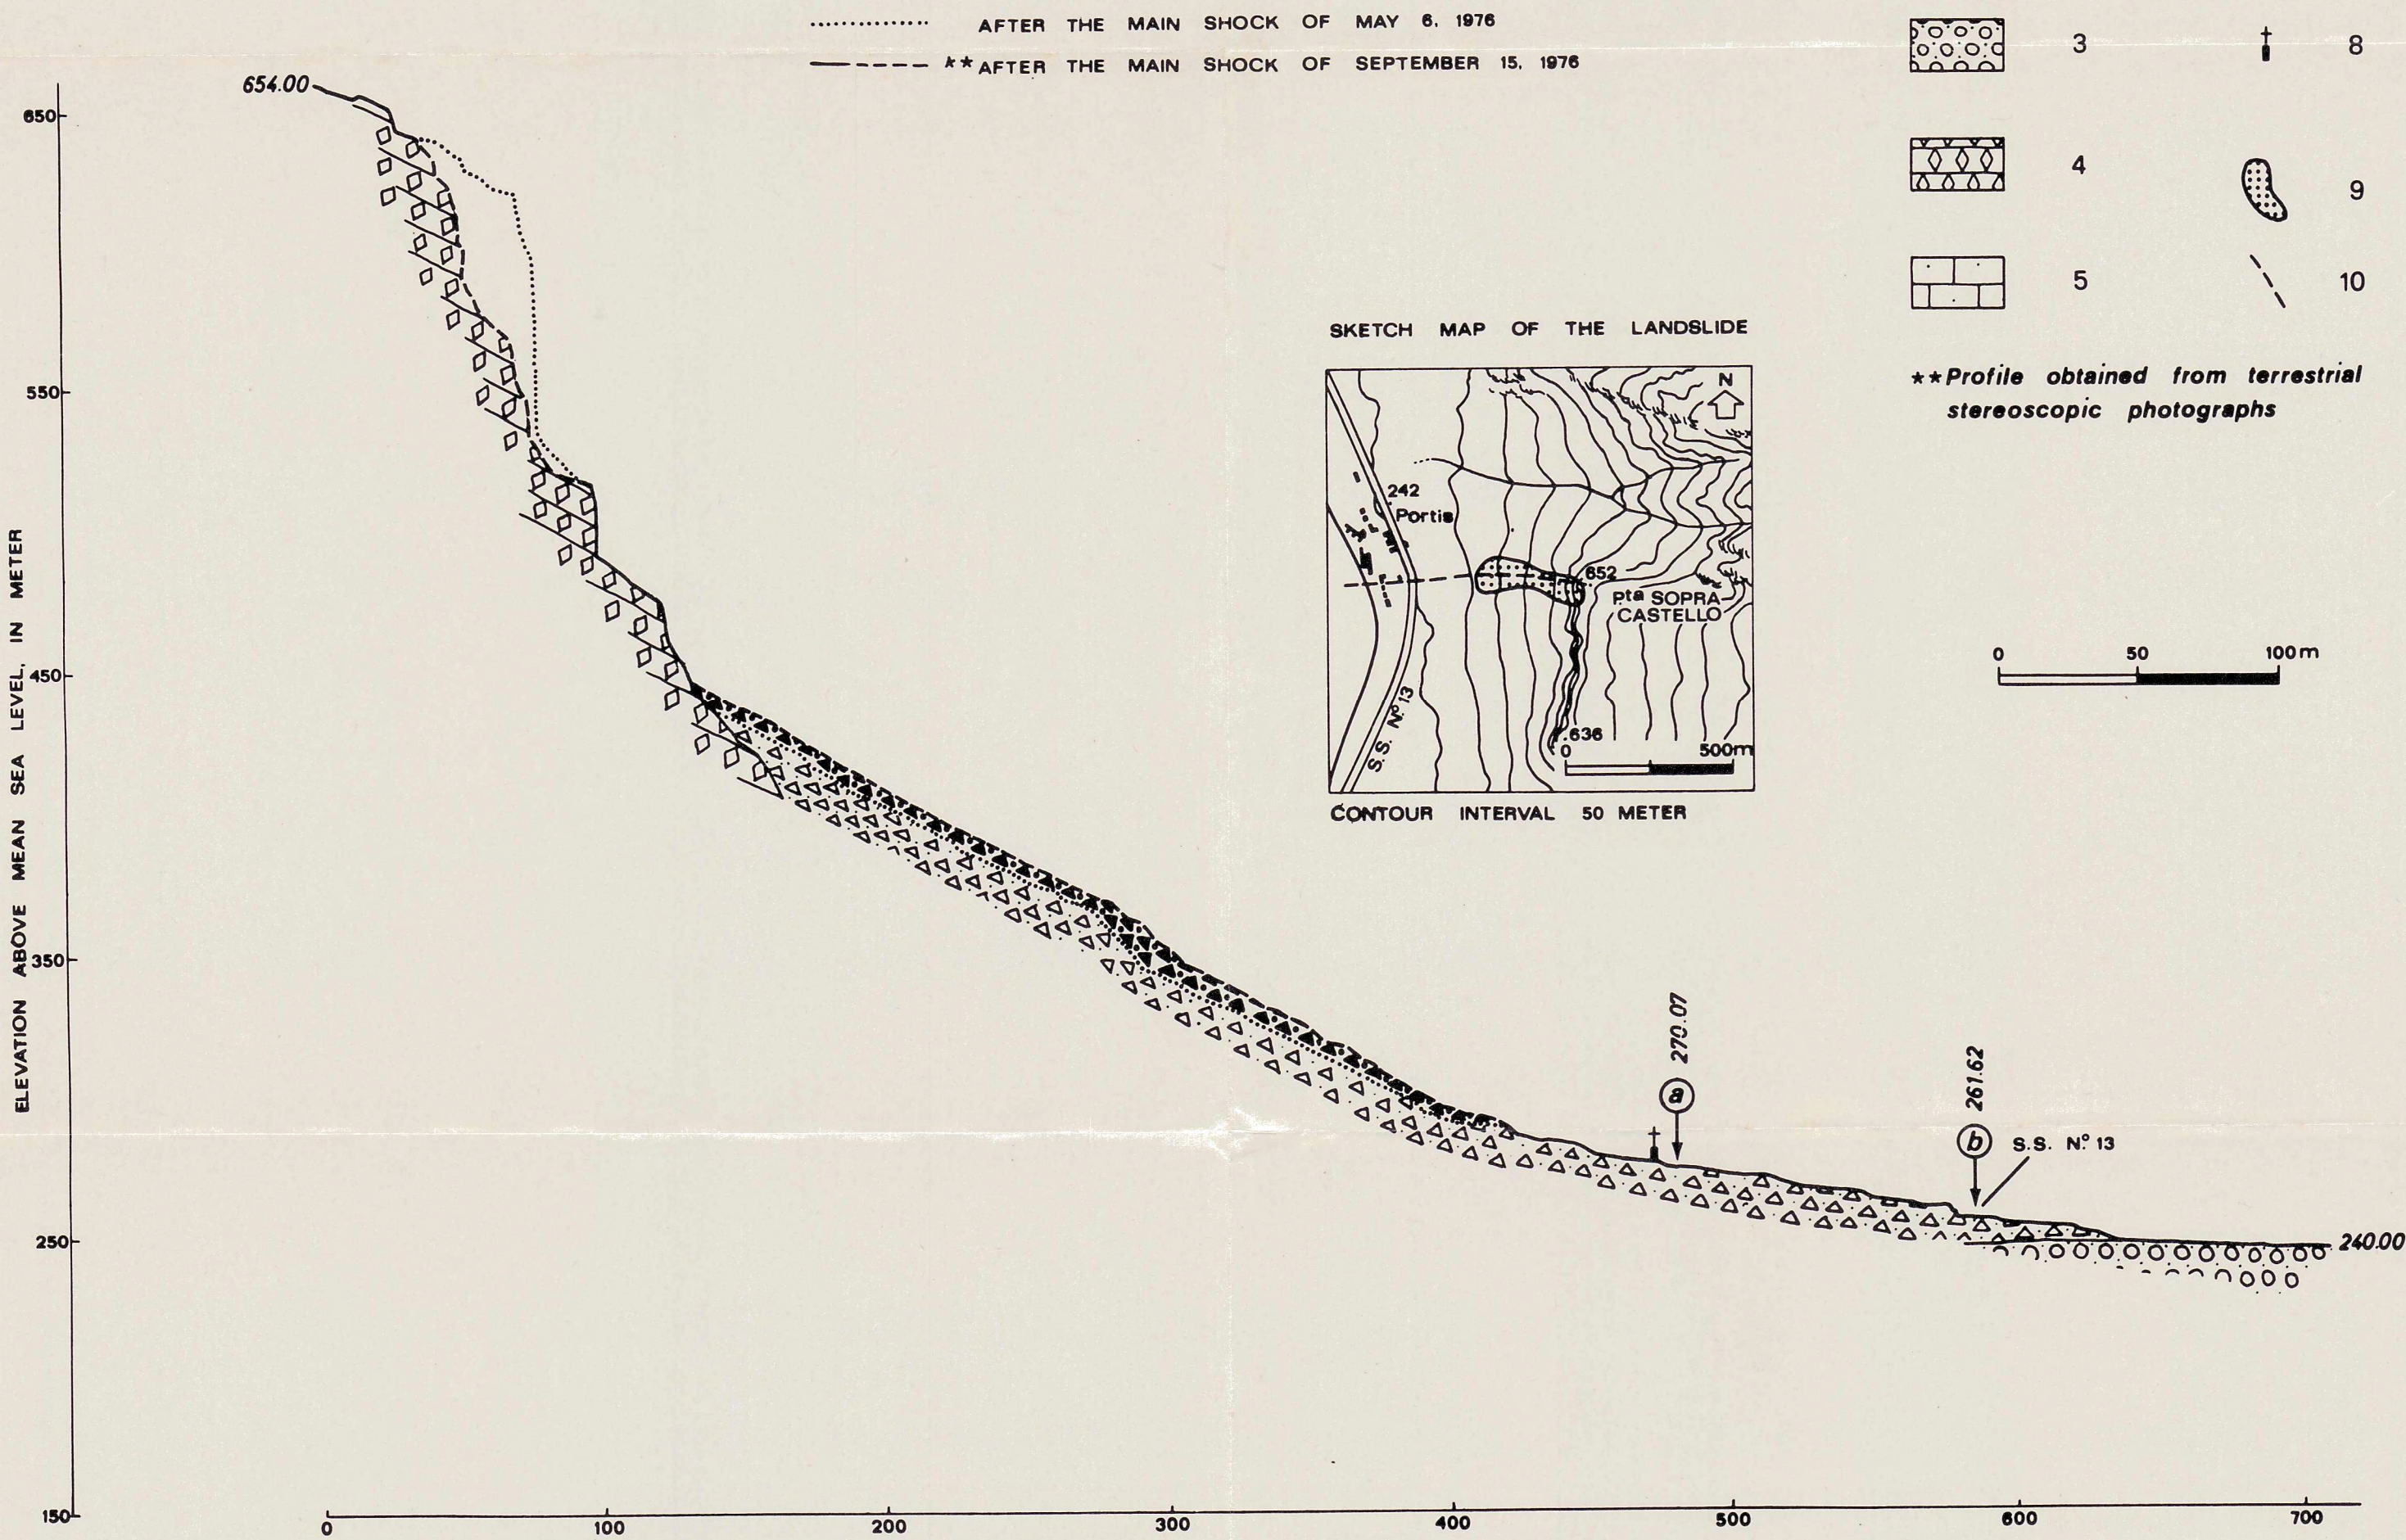
P.<sup>ta</sup> SOPRA CASTELLO LANDSLIDE

\*\*Profile obtained from terrestrial stereoscopic photographs
